DOCUMENTATION OF ENVIRONMENTAL INDICATOR DETERMINATION

RCRA Corrective Action Environmental Indicator (EI) RCRIS code (CA725)

Current Human Exposures Under Control

Facility Name: DuPont Performance Coatings, Inc
Facility Address: 7961 Winchester Road, Front Royal, Virginia 22630
Facility EPA ID #: VAD 980 554 539

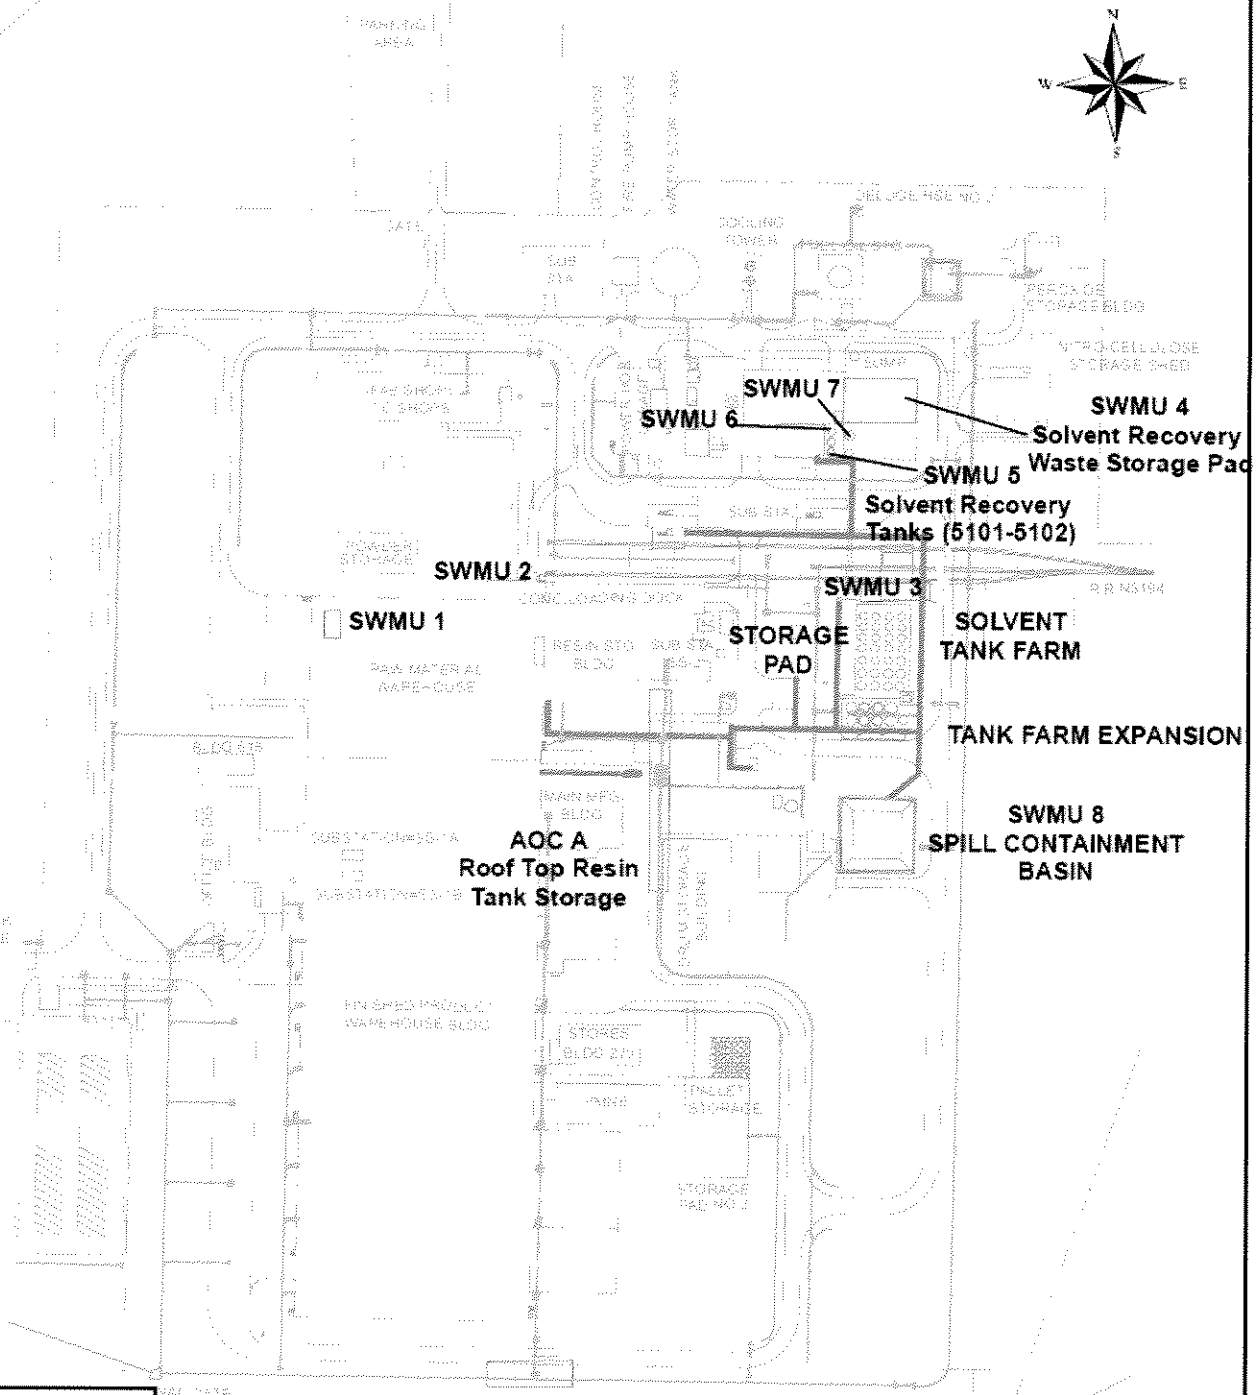
Title: Site Layout Map with Soil Sample Locations
E.I. CA 725
DuPont Performance Coatings, Inc.
Front Royal, Virginia

Site data evaluated for this step included shallow confirmatory soil samples collected from six locations associated with AOC A (Roof Top Resin Tank Failure) and AOC B (Roof Top Product Tank Overflow) at locations illustrated on Figure 2. One surface soil sample (collected from depths less than 2 feet below ground surface [bgs]) and two subsurface soil samples (collected from depths greater than 2 ft bgs) were collected from each AOC to evaluate documented past releases at the areas. Soil sample locations are detailed in Figure 2. Soil samples were analyzed for Appendix IX volatile organic compounds (VOCs) plus tentatively identified compounds (TICs) using USEPA SW846 method 8260B. Analytical results are summarized in the table presented below and compared to the EPA, 2009, Regional Screening Levels for Chemical Contaminants at Superfund Sites, May 20.

AOC B
Roof Top Product Tank Overflow
